**STORM WATER OUTFALL STUDY**  
**HORRY COUNTY BEACHES**  
**FOR**  
**HORRY COUNTY, SOUTH CAROLINA**

MARCH, 2001

REVISED FEBRUARY 2002

PREPARED BY  
DAVIS & FLOYD, INC.  
ENVIRONMENTAL DIVISION  
GREENWOOD, SOUTH CAROLINA

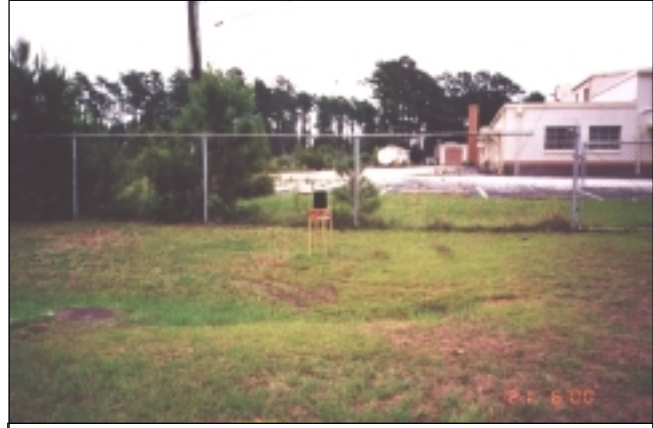
beachfront hotel is located in an area near Lake Arrowhead Campground, just north of the Kingston Plantation. The third rain gauge was mounted on the ground in the yard beside the Davis & Floyd, Inc. Mobile Environmental Laboratory, which was parked inside the fenced Horry County Maintenance Facility located at 1282 Howard Parkway. The building at this site is referred to as Building Number 516 within the South Park Village, formerly the Myrtle Beach Air Force Base.

**Rain gauge at Davis & Floyd Mobile Lab**

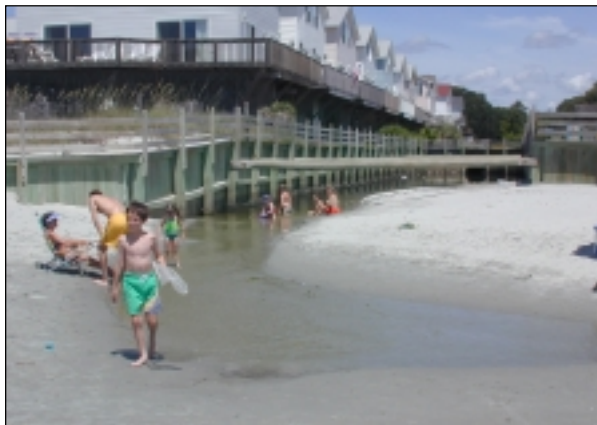
The drainage basin (HCSBD01) that discharges to the ocean at Outfall HCSBD01-00 flows through an unnamed swash at the southern end of Ocean Lakes Campground. The drainage

**Outfall HCSBD01-00**

basin, which covers approximately 470 acres, includes a large portion of the campground, a section of Highway 17, Deerfield Plaza, a portion of Deerfield Plantation, and several commercial properties. The width of the swash near the beach is approximately 20 feet. Flow

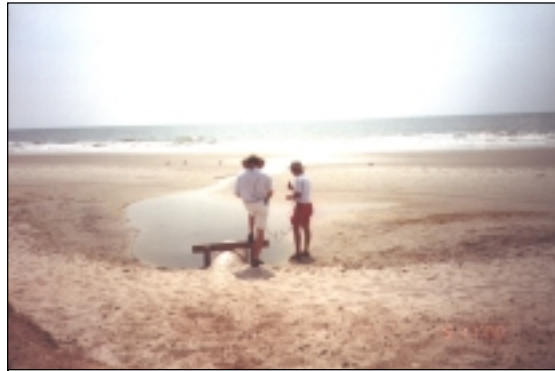
**Dry Weather Sampling @ HC SBD02-00**

weather varied substantially. A total of 89% of the samples collected during dry weather resulted in less than 2,000 colonies/100ml. As a result, 11% of the dry weather sample results were greater than 2,000 colonies/100 ml. It was noted that the

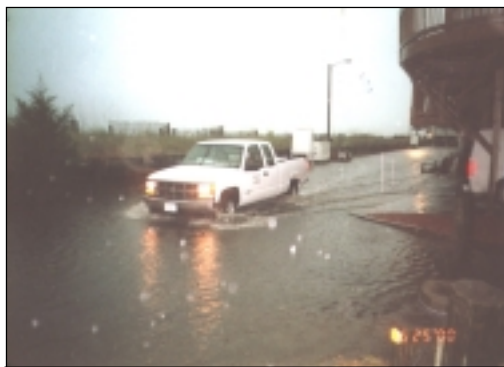
**Flooding Near HC SBD01-00 during Rain Event**

corresponding rainfall data is overlaid at the top of each graph of in enterococcus concentrations. As expected, approximately 80% of the samples collected during rain events resulted in enterococcus bacteria concentrations that exceeded 2,000-colonies/100 ml. Several graphs for each of

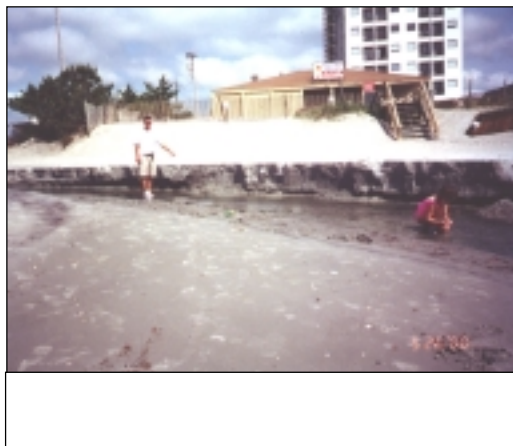
The photograph clearly indicates that a significant amount of sand was lost during the rainfall and subsequent surface water runoff. In addition, the graphs present the results during the May 25<sup>th</sup> rain event and on the day after. The final graph is for May 29<sup>th</sup>, several days after the rain event.

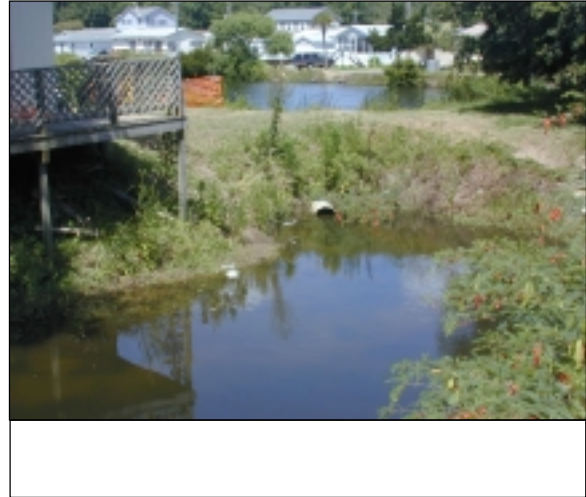
After several weeks of collecting samples at each of the outfalls that could be sampled during dry weather, it was determined that sampling should be focused within a specific selected drainage area. As a result, a total of eleven sampling locations was selected within the drainage basin that discharges to outfall HCSBD01-00 (basin HCSBD01). This drainage basin was chosen because it contained elements indicative of the entire study area. The sampling points were

chosen in locations where changes in bacteria counts were anticipated, such as pond inlets and outlets. A total of eight samples was collected from each of the locations HCSBD01-01 through HCSCD01-10 during the period May 25<sup>th</sup> to June 8<sup>th</sup>, with only four samples collected at HCSBD01-11. The results of this work are presented in Appendix L. A review of the data indicates that enterococcus concentrations for HCSBD01-01, HCSBD01-02, HCSBD01-08, and HCSBD01-10 on May 31<sup>st</sup> were 2,419.2 colonies/100 ml or greater. Each of these sample locations would be considered to be part of the main path for the swash through the campground.

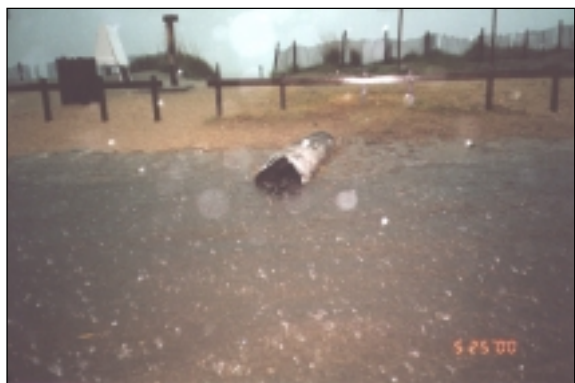
**Flooding in Campground**

Overflows commonly occur during wet weather conditions, when infiltration and/or inflow overload the sewer system. Infiltration is typically the result of extraneous water entering the sewer system through joint leaks in pipes and/or manholes, and occur when the water table

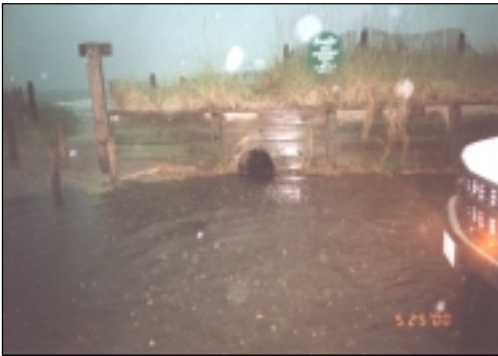
**Flooding Behind Dunes**

Davis & Floyd, Inc. personnel observed significant storm water back up on the backside of the dunes in the study area. When the storm water is allowed to backup behind the dunes, it is possible that flow enters the sanitary sewer systems through manholes and even legal sewer hook ups that turn out to be below the surface elevation of the backed up storm

water. The photographs herein are examples of storm water back up behind the dunes. A major source of inflow is typically illegal storm drain connections to the sewer, such as roof storm drains, crawl space and basement pumping systems, roadway and parking lot storm drains, etc. Additionally, inflow can result from surface runoff entering the system through holes. A common inflow problem is a manhole cover with holes located in an area that floods, allowing the surface runoff to enter the system through the manhole cover holes. This can also occur where the sewer pipe has broken in an area that floods, or in an area where a pump station is subject to flooding. These situations were observed in several locations throughout the study area, i.e. sewage systems in many of the areas close to the beach are not able to process the volume of water that enters them during excessive rain events and flooding. Grand Strand Water and Sewer Authority (GSW&SA) indicated that several sewer overflows were known to have occurred during the study period. The pump station near the intersection of SC544 and US 17 overflowed in July for over 30 minutes, because the force main was clogged. While working in Pirateland Campground in August, a contractor cut a force main that spilled wastewater into the swash. It is not uncommon for several of these overflows to occur each year. GSW&SA also indicated that their systems are not significantly impacted by rain events less than two inches. More problems are seen when rain events exceed four inches. They indicated areas where storm

It is recommended that a feasibility study be made to evaluate existing drainage and determine where improvements can be made to decrease flooding. The initial focus of this study should be around sanitary sewer systems, which have the greatest potential for overflowing during flooding. One of items of greatest concern would be gravity sewer lines and pump stations serving complexes and that are close to the beach. Additional consideration should be given to adding storm water outfall pipes through the dunes or campgrounds to repair outfall pipes that exist, but are not operational. These additions and repairs may help reduce flooding in some of these areas.

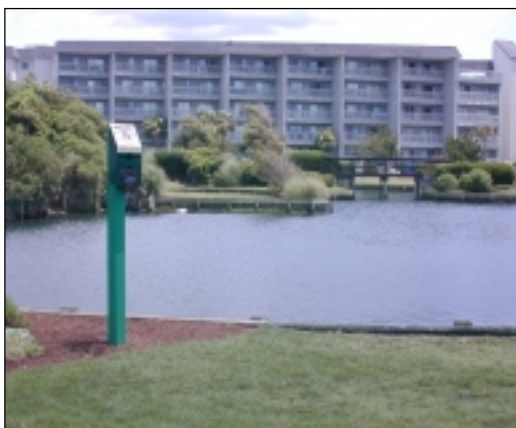
**Pet Relief Station Near Outfall HS  
SBD02-00**

waters. Numerous dogs were encountered on a daily basis during the study. In at least one case, owners were provided a specific location for their dogs to relieve themselves. The photograph above is of a pet relief area in one of the campgrounds. In addition, it is not uncommon to see people riding horseback on the beach within the study area. Wild animals

It is recommended that consideration be given to the formulation of ordinances to prevent or require certain activities such as cleaning up after pets. The use of ordinances could be publicized and used as a tool to reduce bacteria contamination in the surf.

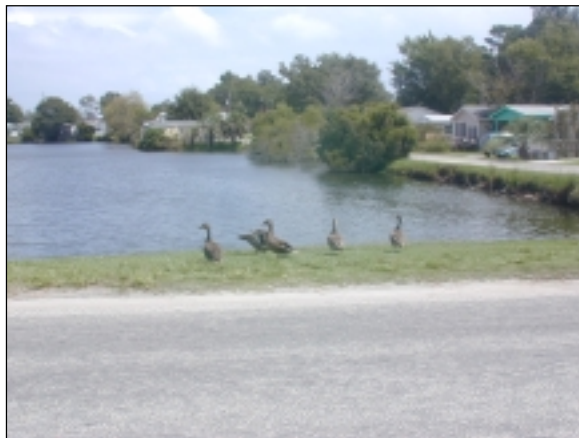
**Ducks at Pond - Typical Throughout Study Area**

such as deer and raccoon are commonly found in the study area. Large populations of ducks, geese, Canadian geese, seagulls, and other waterfowl, as well as numerous birds, were

encountered throughout the study area. A nest of swans was also found during the study. All of these contribute significantly to the contamination problem.
